### DEVELOPMENTAL HALT Report

R-00000371-1

**Product Tested:** Cobra Cure FX™ UV LED curing system

**Report Date:** 21<sup>st</sup> Oct 2016

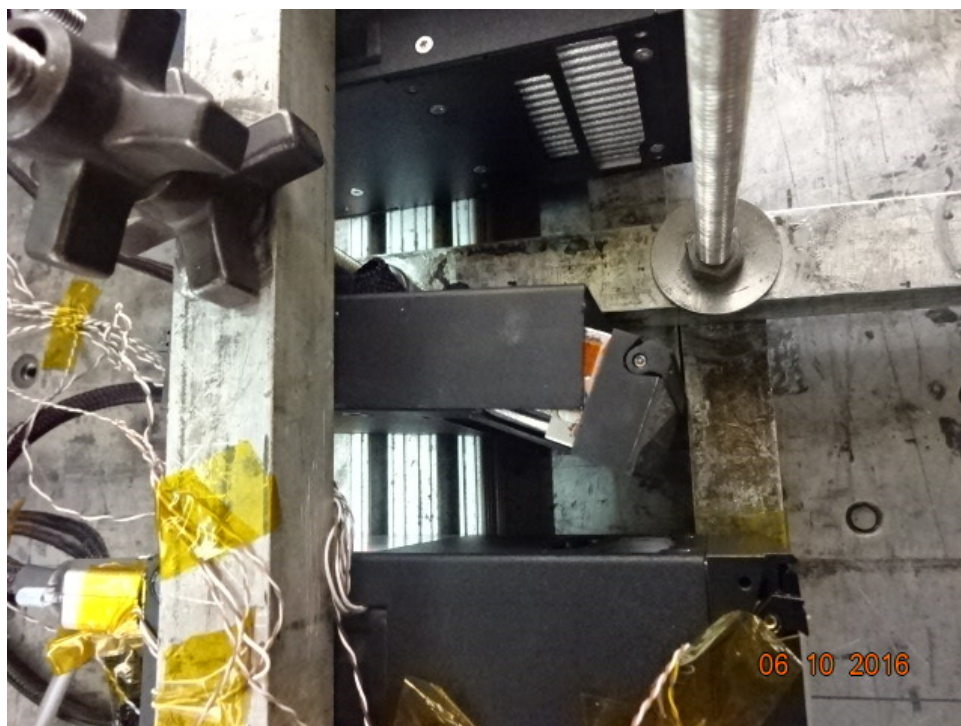
At 30G an intermittent FX1 395 unit started reading 18VDC; it was also observed that there were loose screws in the heads of FX1 395 (188528) and in FX2 395 (188256). These were tightened and testing continued.

- FX1 365 (188532) and FX1 395 (188529) had a single PCB screw loose inside
- FX1 365 (188533) had a cracked cover
- FX1 395 (188528) intermittent faulty voltage output, cover cracked, case screws were loose and the head was falling off

Figure 20: Front Face off on FX1 395 unit loose screws and damaged cover
