## DEVELOPMENTAL HALT Report R-00000371-2

**Product Tested:** Cobra Cure FX2™ UV LED curing system  
**Service Proposal #:** S00000371\*  
**Job #:** J11539-7868  
**Date Received:** 04<sup>th</sup> Oct 2016  
**Test Dates:** 04<sup>th</sup> Oct 2016 – 06<sup>th</sup> Oct 2016  
**Report Date:** 21<sup>st</sup> Oct 2016

**Client(s):** Ken Reynolds  
Prophotonix,  
3020 Euro Business Park,  
Little Island,  
Cork,  
Ireland

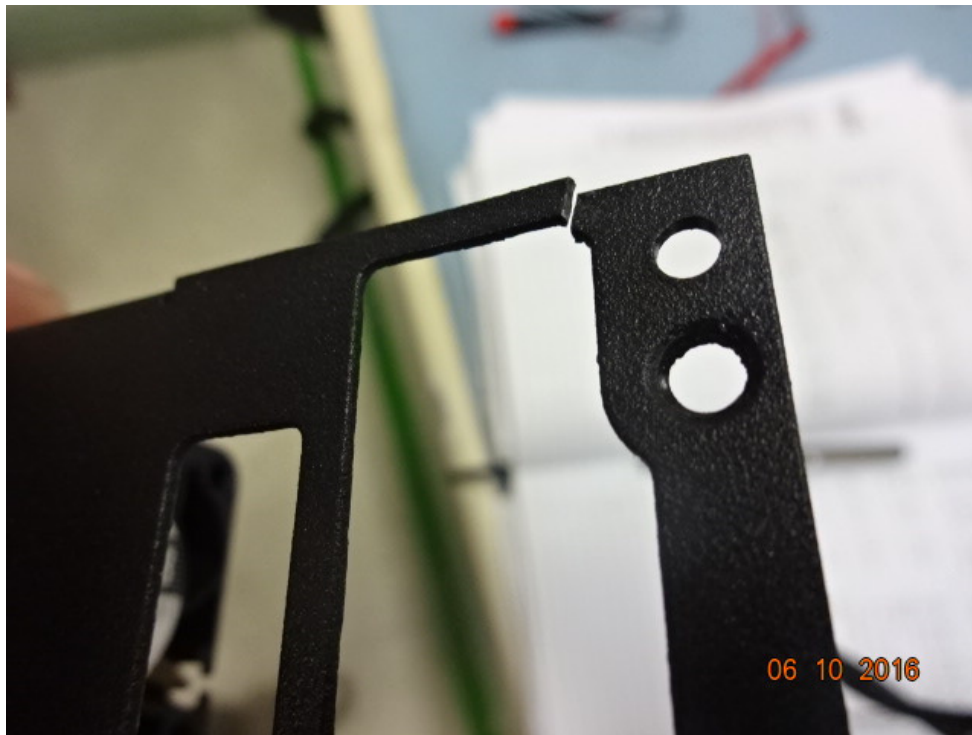
At 40G a flexi cable became loose internally on an FX2 365 unit. When the unit was examined the cable was sideways but not out of its position. It was also found that two of the FX2 365 had cover damage where the cover was damaged at the centre of the unit behind the heatsink.

- FX2 365 (188138) and a FX2 365 (188139) had cracked covers
- FX2 395 (188256) and FX2 395 (188257) were OK

Figure 19: Cover Damage on unit following vibration testing

Each of the failures found during the HALT process (see section 2.0) needs to be examined and the root cause of the failure determined. Once the root cause of each failure is determined, engineering judgment is used to determine whether corrective action should be taken to fix the problem. The product should then undergo a verification HALT to ensure that the design margins have been increased to the fundamental limit of technology and that the fixes made did not induce new failure modes. The ruggedisation of the product will not be increased unless each of the failures found during the HALT process are taken to root cause and corrective action implemented.

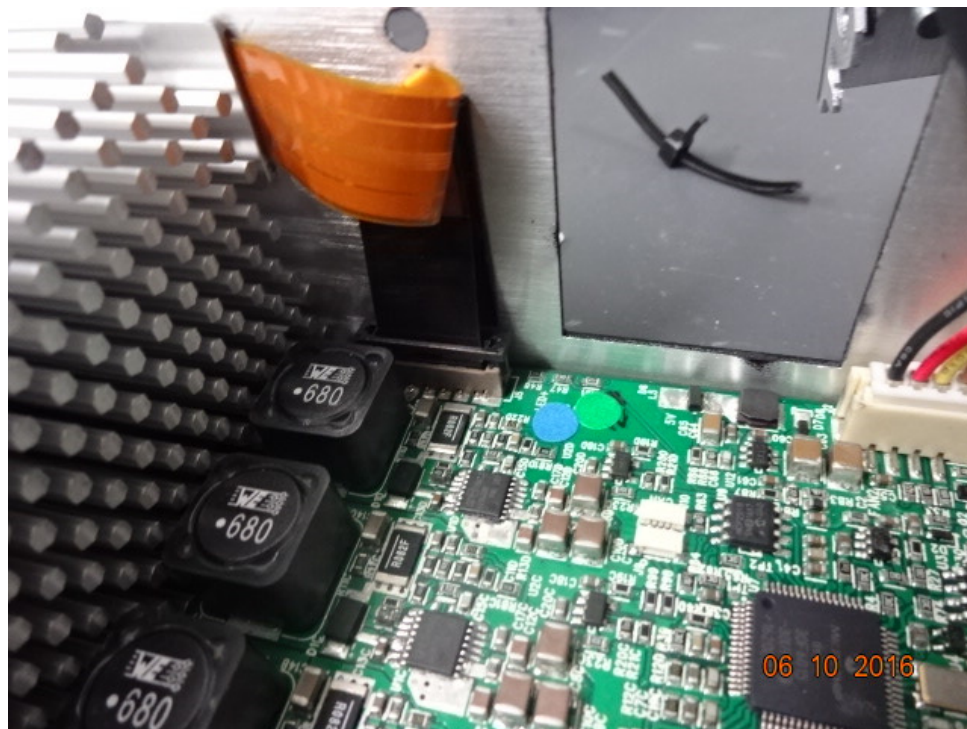
1. The units were powered throughout the testing and monitored for any issues. A functional test was performed at each dwell.
2. At 30G it was observed that there were screws loose in the head of FX2 395 (188256)
3. At 40G a flexi cable became loose internally on an FX2 365 unit. When the unit was examined the cable was sideways but not out of its position.
4. At 40G it was also found that two of the FX2 365 had cover damage where the cover was damage at the centre of the unit behind the heatsink.
5. All the units continued to operate as expected within specification and no observable issues were recorded.

Figure 20: Flexi cable that became loose during vibration testing and failed at 40G
