### DEVELOPMENTAL HALT Report

R-00000371-1

**Product Tested:** Cobra Cure FX™ UV LED curing system

**Report Date:** 21<sup>st</sup> Oct 2016

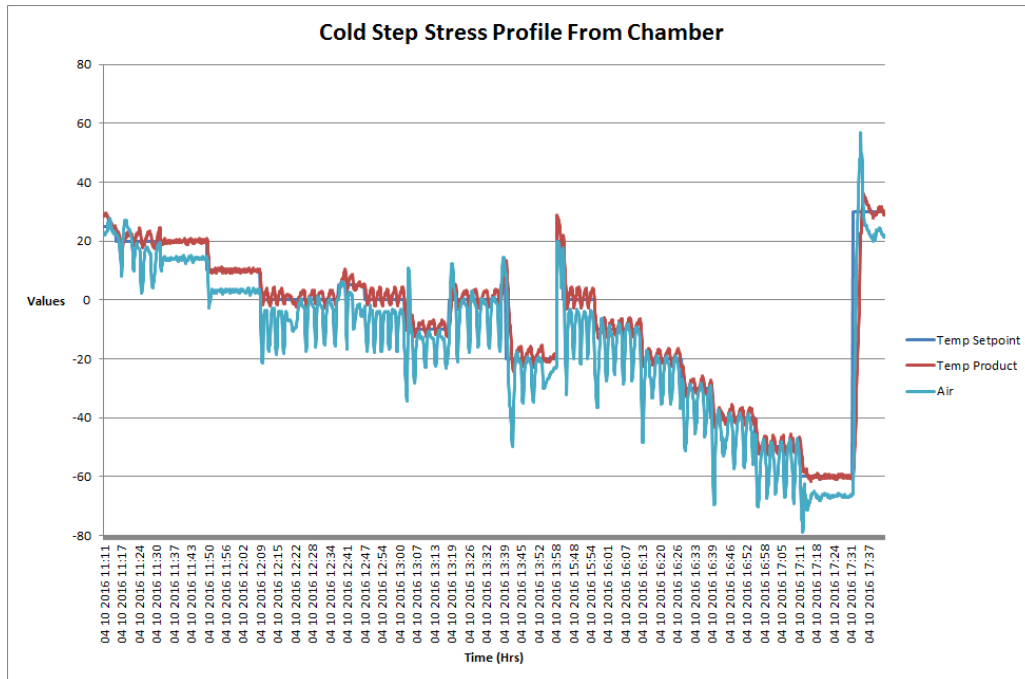
**Figure 3 Cold Step Stress Profile from Chamber**

The units were functionally tested at each dwell down to -60°C and were powered throughout the cold thermal step stress test as shown in figures 3 Cold step stress profile from chamber and figure 6 Cold step stress component profile.

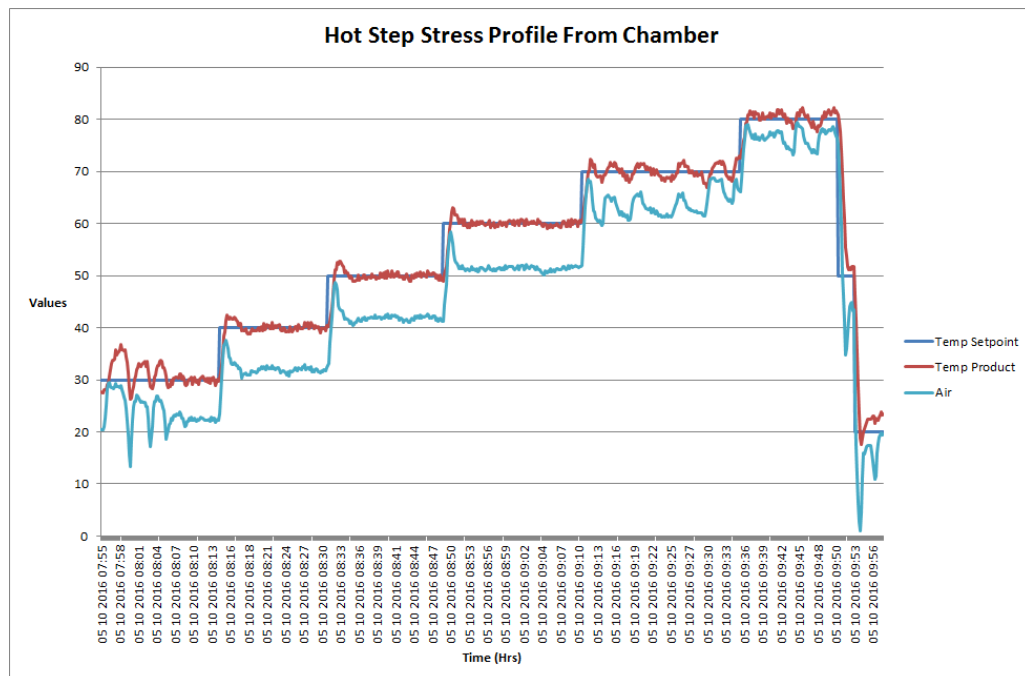
**Figure 4 Hot Step Stress Profile from Chamber**

The units were functionally tested at each dwell up to 80°C, as shown in figures 4 Hot step stress profile from chamber and figure 7 Hot step stress component profile. . The units were powered throughout the testing and monitored for any issues. A functional test was performed at each dwell.

It was observed that at 70°C 4 of the FX1 UV LED turned off, however when the power supply was turned off for a few minutes and on again 2 units powered up with UV LEDs, however within a few minutes all of the UV LED switched off again on the FX1 units.

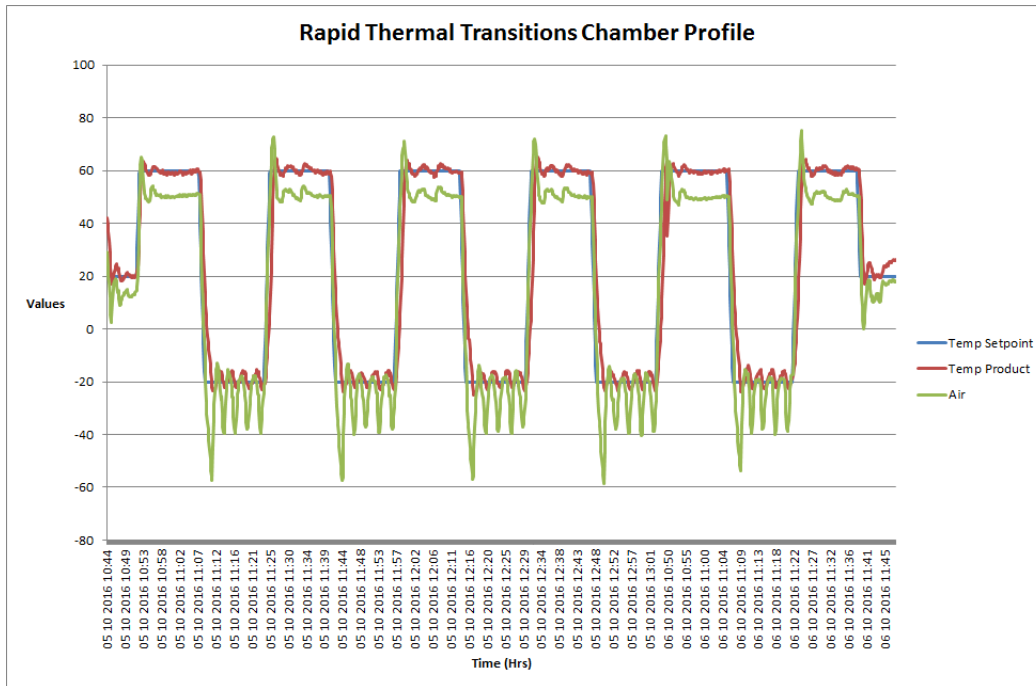
Figure 5: Rapid Thermal Transitions Chamber Profile

The units were powered throughout the testing and monitored for any issues. See figures 5 Rapid thermal transitions chamber profile and figure 8 Rapid thermal transitions component profiles. A functional test was performed at each dwell.
